Five-Year Review Report

Five-Year Review Report
for
Summit Equipment & Supply, Inc. Site
Akron
Summit County, Ohio

August 2003

Region 5
United States Environmental Protection Agency
Chicago, Illinois

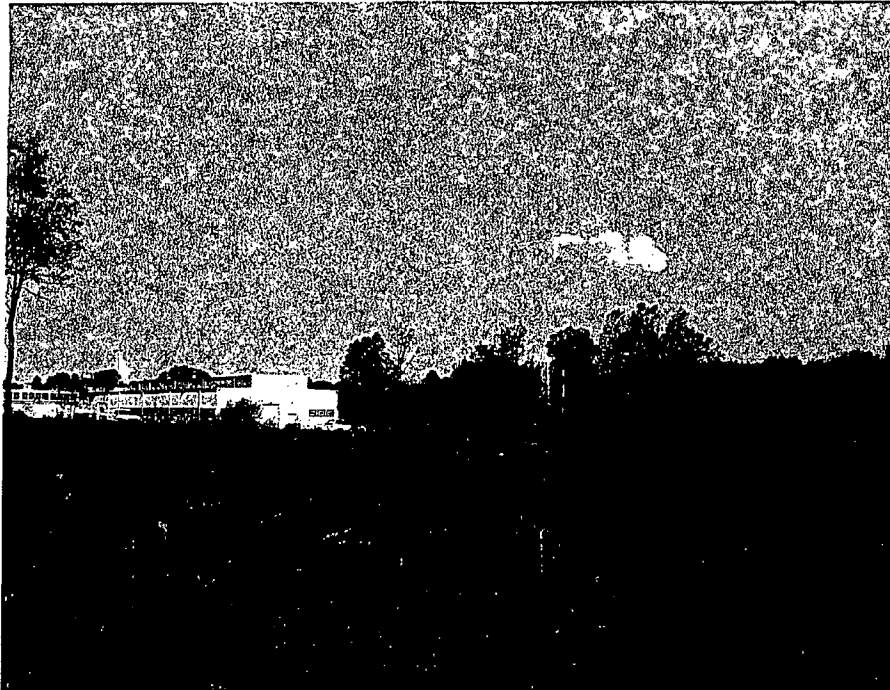
View from middle of SES site looking West - 5/13/03

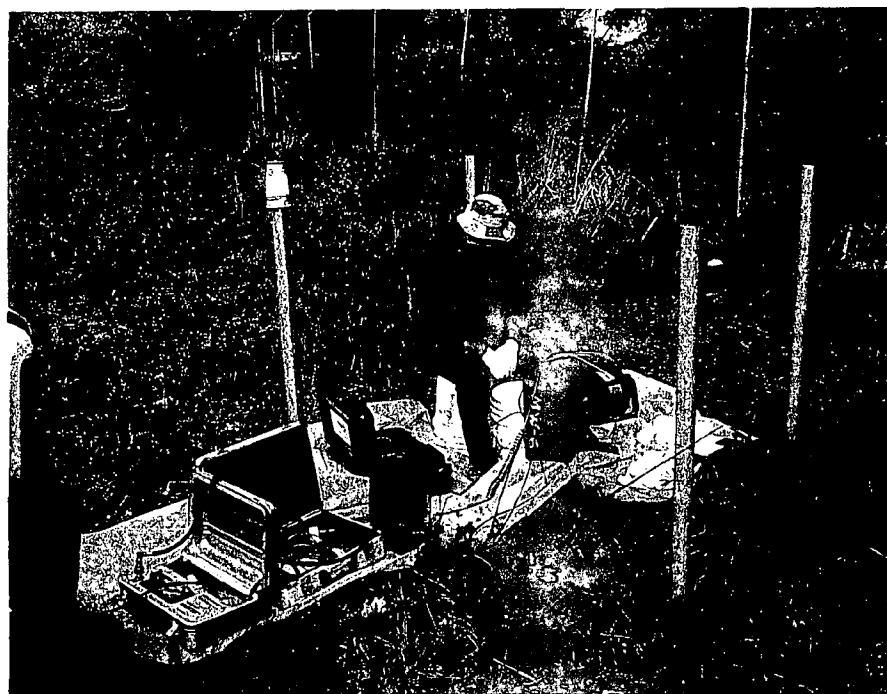
Sampling being conducted at MW-6 on 5/13/03

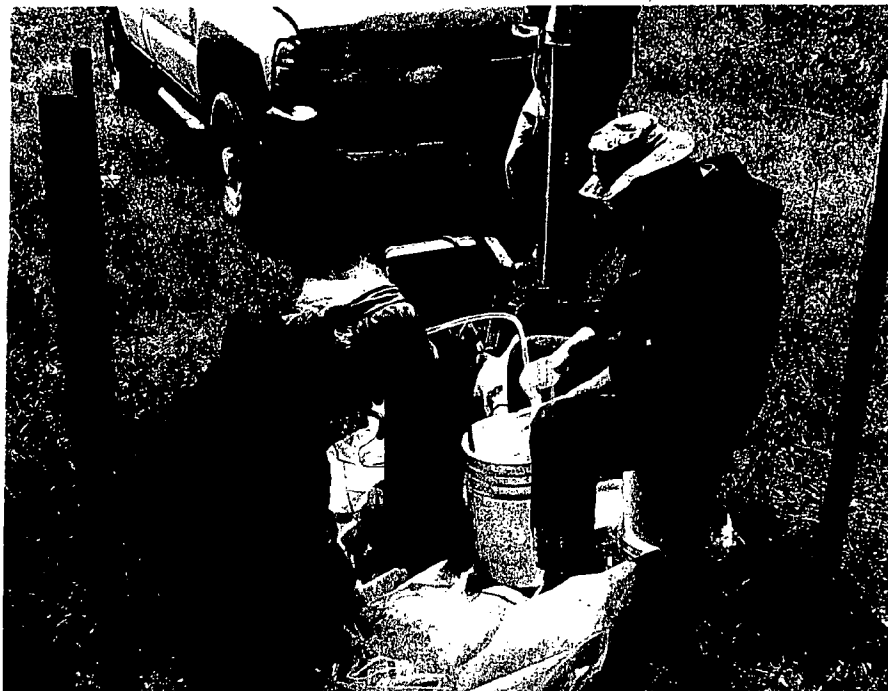
Sampling being conducted at MW-6 on 5/13/03
